Conservation of wooden sculpture of saint Anne

A. TROCHIMOWICZ

Abstract: *Conservation of wooden sculpture of saint Anne.* The wooden sculpture, originally primed and polychromed, was for many years exposed to atmospheric influence. The external technological layers – the priming and the paint layer were not preserved. The wood deteriorated to a high degree. The process of conservation allowed for maintaining the sculpture's function as a relict and its reception as a work of art.

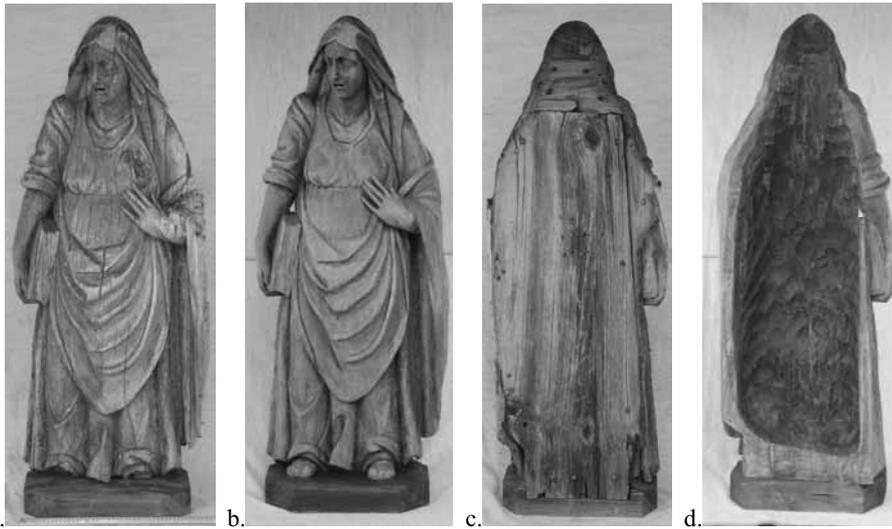
Placing the sculpture in an open shrine with only a roofing exposed it to environmental fluctuations, which caused complete deterioration of its polychrome. Consecutive working of rain, melting snow, and sun lead to humidifying, and then parching of the glue priming which resulted in its flaking and eventual loss, followed by cracking and degradation of the wood. The condition of the sculpture testified to its exposure to long lasting humidity during the Autumn and Winter seasons alternating with the dehydrating influence of the sun during the Summer months. The humidified wood swelled, and then contracted as it dried which caused cracking. This process, at first only concerning the external layers, in time penetrated deeper into the wood. Damage caused by fungus and mould resulted in destruction of the structure of wood (the base of the sculpture and the left arm of the figure). Water which saturated the wood during the rainy Autumn season froze in Winter thereby extending in volume, and causing its further cracking and delaminating. All the above mentioned processes have contributed to destruction of the sculpture.

The bottom part of the original figure no longer exists. During the previous conservation process it was replaced, and a structure holding the figure upright was introduced.¹ The extent of the damage: the altered surface of the wood, the cracks, and the

a. b. c. d.
II.1 Saint Anne of Wilanow. The front of the sculpture before and after conservation (a,b), the back of the sculpture before and after conservation (c,d)

Conservation work began with the disinfection of the object². Beech wood pegs, about 5 mm in diameter, were pasted underneath the sculpture, which enabled the vertical adjustment of the sculpture as well as determining the actual height of the figure. After that all losses at the reverse side and in the place of feet of the sculpture were supplemented by linden wood. Henkel Pattex glue was used for bonding. Major losses unfit for repairing and losses larger than a few millimeters at the places of joints were filled with Axson SC 258 epoxy paste³, used mainly in places where the wood has been leached by rainwater – i.e. on the left shoulder and at the bottom of the sculpture.

After small fissures were filled and their surfaces processed the sculpture was coated with 12% shellac solution in denatured alcohol. When dried, the retouch has been done with Rembrandt acrylic paints. Maimeri retouching paints dissolved in Maimeri Solvent Forte were used for a finishing touch. The entire surface of the sculpture was covered with Gualtiero Meazza S.R.L. Novecento Legno liquid wax.

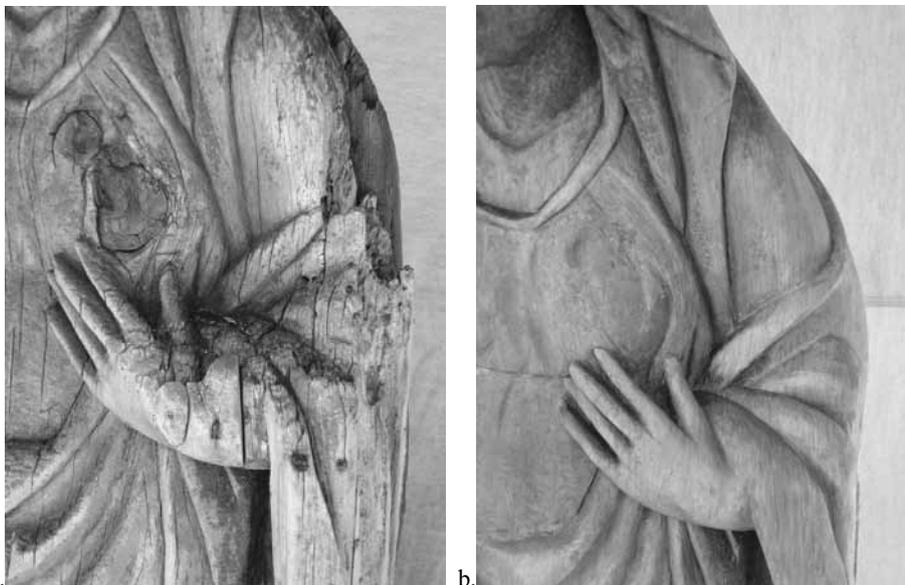
a. b.
II.2 Saint Anne of Wilanow. A close-up of the left arm. Before conservation (a), and after conservation (b)

The cavities in the left arm, in the folds of the robe on this arm, the right thumb, and in the fold on the back side of the robe below the belt, and below the foot were filled with dry lime-wood. Narrow strips of wood were inserted into the cracks on the saint's head and on the stomach⁴. Large supplements at the reverse side of the sculpture were fitted in the places where the original surface was chopped down. Henkel Pattex glue was used for bonding. Special emphasis was placed on removing the old wood thoroughly up to the healthy tissue during the bonding process. Major wooden supplements adhered quite well to the original surface, as they were pasted in the places where the wooden features were added during the previous conservation intervention after the drastic alignment of the surface. The structure of the degraded wood was strengthened during the pasting work by the use of the local injection of Rohm&Hass B72 Paraloid solution in toluene at relatively low concentrations (5-10 %). The treatment was repeated several times. Small fissures and connections between the supplements and the original object were filled with ZAR Latex Wood Patch. The surface was thereafter mechanically wet processed with the use of cork.

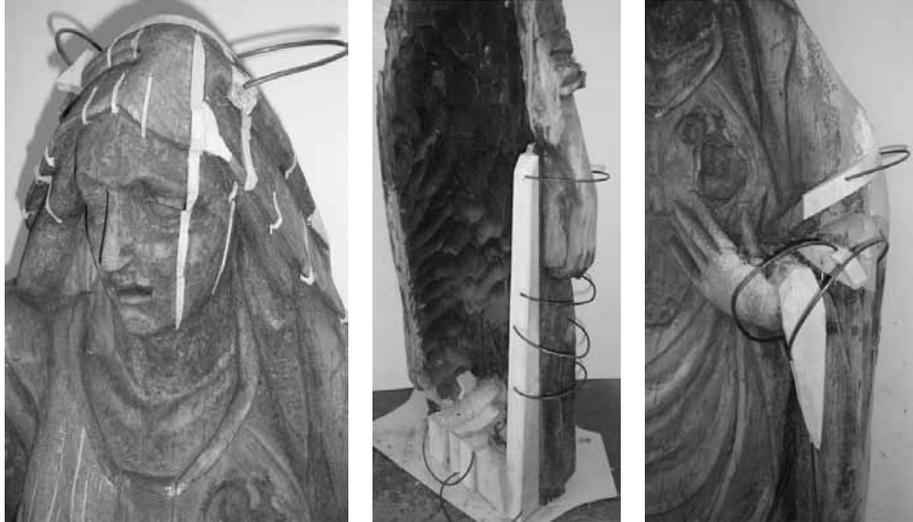
II.3. Saint Anne from Wilanow. A close-up of the sculpture during the process of insertion of wooden fillings
