## **Analysis of tool life criterion during laminated chipboard milling**

JACEK WILKOWSKI, JANUSZ ZIELIŃSKI, PAWEŁ CZARNIAK  
Wood Mechanical Processing Department, Warsaw University of Life Sciences– SGGW

**Abstract:** *Analysis of tool life criterion during laminated chipboard milling.* Direct and technological indicators of tool wear were examined during climb milling of laminated chipboard produced by three different producers. Machining was conducted with usage of CNC working center with usage of four tools, perceived in industry condition as not appropriate to the further work because of insufficient machining quality. Analysis of tool life criterion based on technological indicator was the aim of the work. Relationships between direct and technological tool wear indicators proved low and average correlations. Quality of investigated kinds of chipboards relevantly differentiated between each other. Thus, there is no reason to use only one tool life criterion for wood based boards made by different producers.

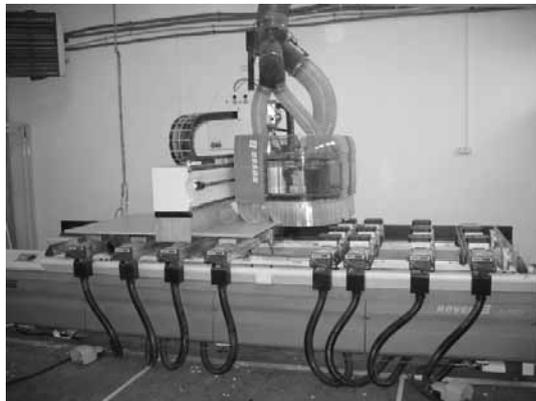
Fig.1. Working center CNC ( Biesse Rover B4.350) from 2006

Milling was carried out on working center CNC ROVER B4.35 - BIESSE (Fig.1). Four router bits with tipped edges from polycrystalline diamond, with diameter 16 mm were used (Fig.2).

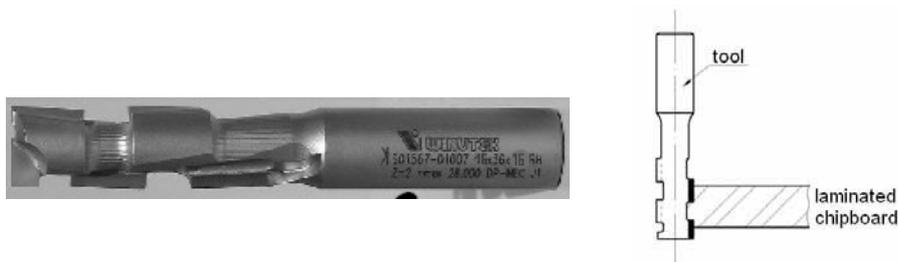
Fig.2. Router bit used in experiments and scheme of machining

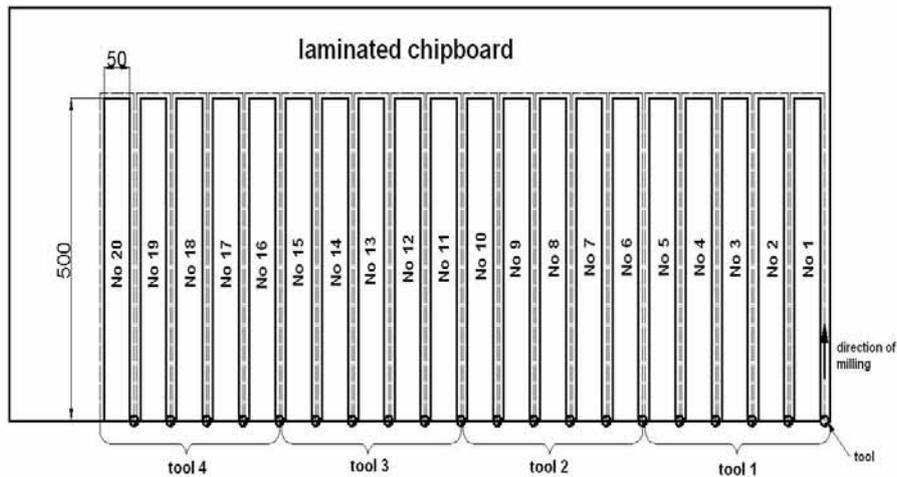
Fig.3. Milling schema of inspection work pieces with their dimensions

Experimental researches were conducted in industry factory JUAN in Warsaw, which produces worktops. Tools taken to experiments were used in standard production process, to different wood based materials. Feed speed and overall time of exploitation for each tool was not monitored on this stage of work. Given tool was working till the moment, when the operator removed the tool from exploitation due to bad edge condition of machined laminated chipboards. So, criterion of tool life was the value of technological tool wear indicator. Then, the tools which were called back from production were next subjected to further investigations. Laminated chipboard was climb milled according to schema showed in Fig.3, through the whole thickness with successive tool. Cutting parameters, constant for all four tools were described in Tab.2. Five inspection work pieces from laminated chipboard, with dimensions 500x50x18mm (Fig.3) was prepared for each tool. Direct tool wear indicator and technological indicator on inspection work pieces, on upper and lower edge of chipboard were obtained after machining.

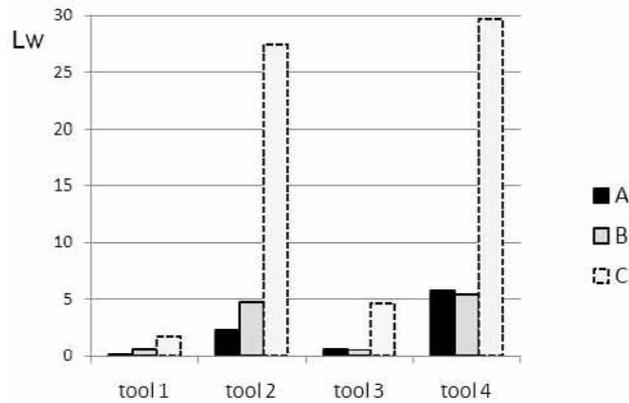
Fig.4. Dependency of chip number  $L_w$  [pc./m] on used tool and kind of chipboard

successive tools and even between particular edges tipped in one tool, too. Technological tool wear indicator for each investigated router bit was showed in Fig.4. The value of technological indicator in case of chipboard „C” is evidently higher than in case of chipboards from other producers. This relationship was confirmed both for particular edges and whole tool. Analysis of technological indicator (number of chips named as  $L_w$ ) proved that the worst machining quality for this chipboard was obtained during milling with tool 2 and 4 (Fig.4). The influence of direct indicator on technological indicator  $L_w$  for chipboards made by different producers was showed in Fig.4. Due to figures below it can be concluded that correlations between these indicators are on average and low level (Fig.5). It means, that besides tool wear degree, another factors such as properties of machined material decided about quality. Therefore, assuming of one tool life criterion in situation when there are used materials which come from different producers is according conducted researches unreasonable.

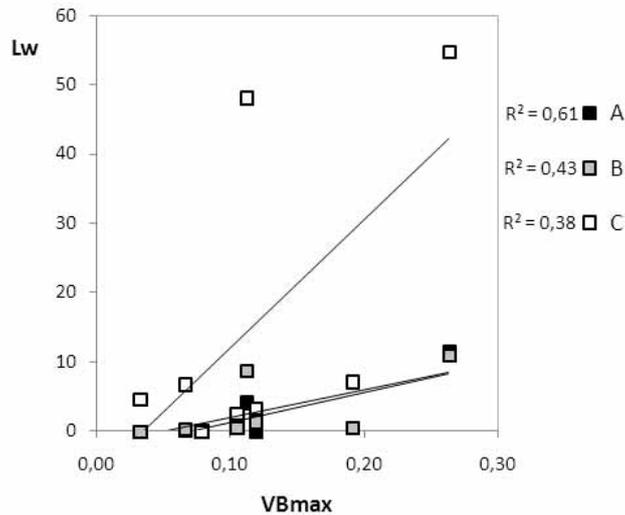
Fig.5. Dependency of chips number  $L_w$  [pc./m] on tool wear indicator  $VB_{max}$  [mm] for particular kinds of chipboards

1. Technological indicators estimated after milling of chipboards made by different producers differentiated significantly between each other. The differences achieved even several hundred percent.
2. Dependences between direct and technological tool wear indicators showed average and low level of correlations. This fact indicates on existing influence of another factories such as properties of machined material.
3. Usage of one tool life criterion based on technological factors which would describe machining quality of the wood based materials from different producers is unreasonable.
4. Tool life criterion based on direct indicators is recommended in scientific researches.
